METLAB
LIMITED

METLAB LTD report number 1231/1A
10 July 2017

SUBJECT - Metallographic examination of various brass cartridge cases

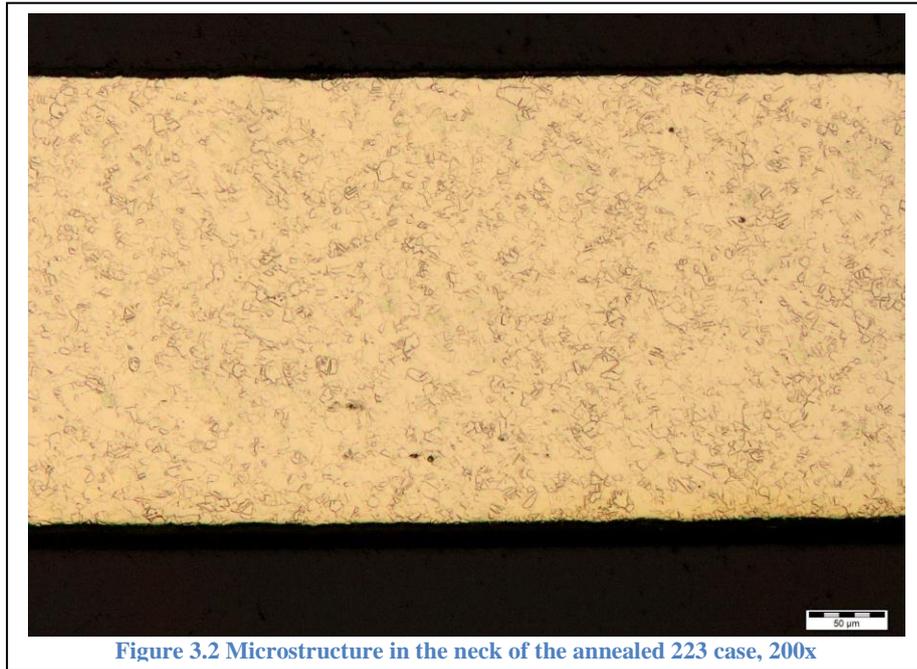
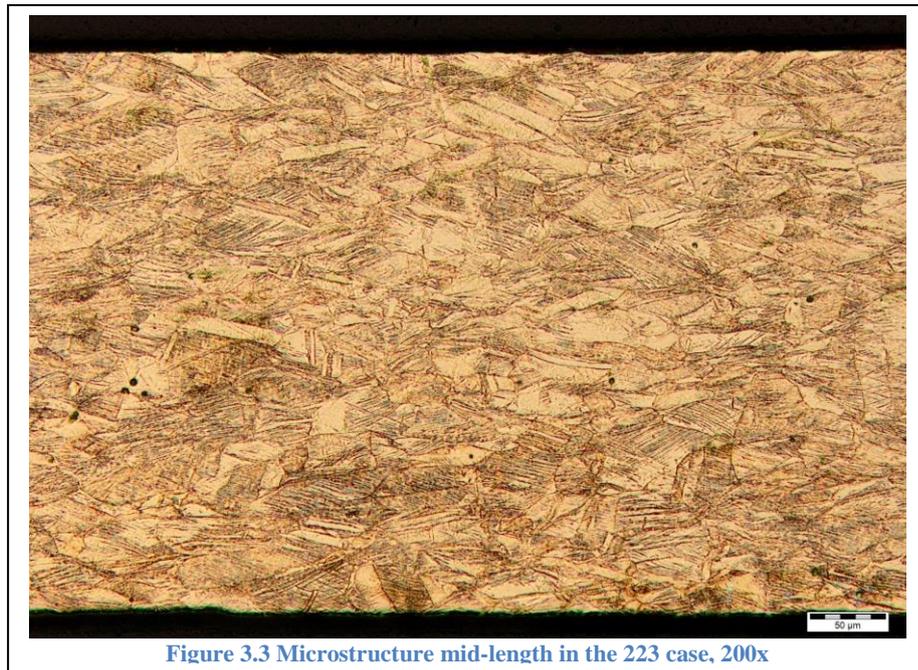
In the cross-sections of these cases it is evident that the neck in the annealed sample has marginally bigger grains than in the virgin case as shown in figures 3.1 and 3.2. We have not attempted to put a number on the grain size at this stage. For the sake of interest figure 3.3 shows the heavily worked microstructure mid-length along the case while figure 3.4 shows the worked microstructure in the head area which the reader might like to compare with the annealed neck areas. Microhardness testing from the neck progressing along the case for 24mm is shown graphically in figure 3.5.

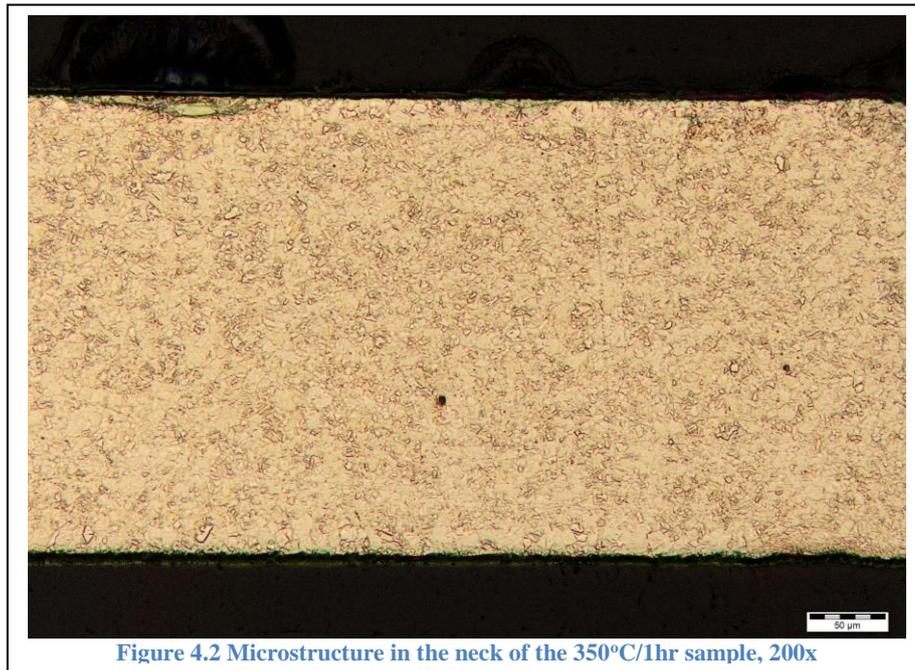
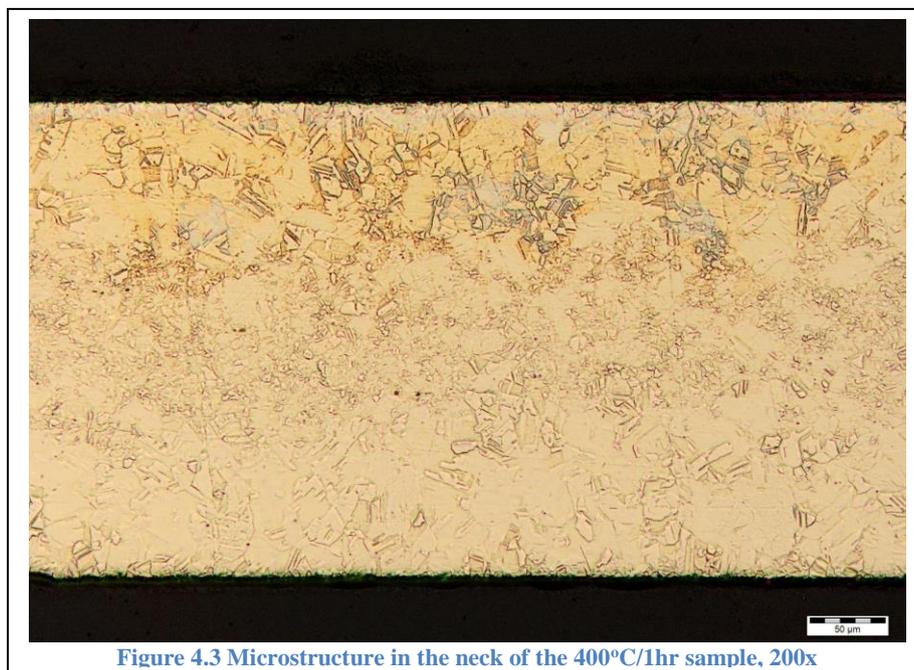
The microstructure in the neck area of the cases annealed for one hour in a commercial heat treatment oven are shown in figures 4.1 to 4.3. It is evident that there appears minimal difference between the microstructure in the 300°C and 350°C samples with a minor reduction in hardness in the 350°C sample. At 400°C however we observe grain growth at both the inner and outer regions of the cross-section while maintaining the finer-grain in the middle of the cross-section. There is a significant reduction in hardness in the 400°C sample as shown in table 4.1.

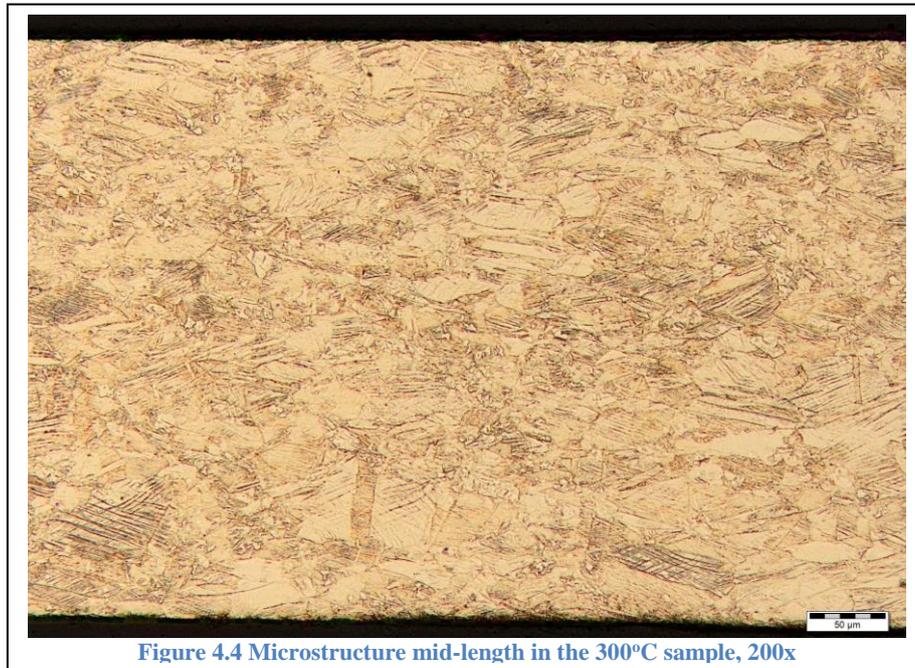
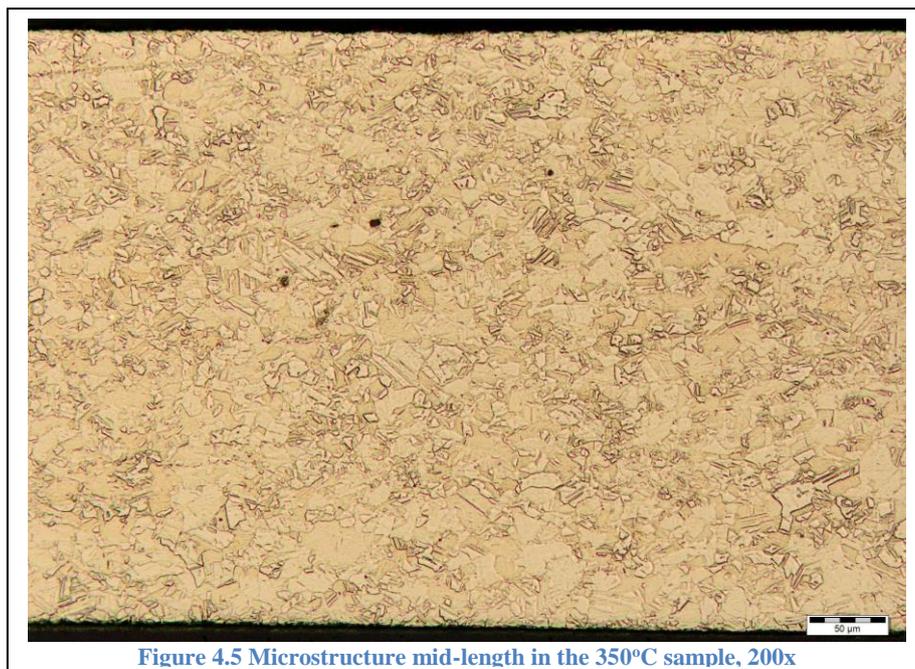
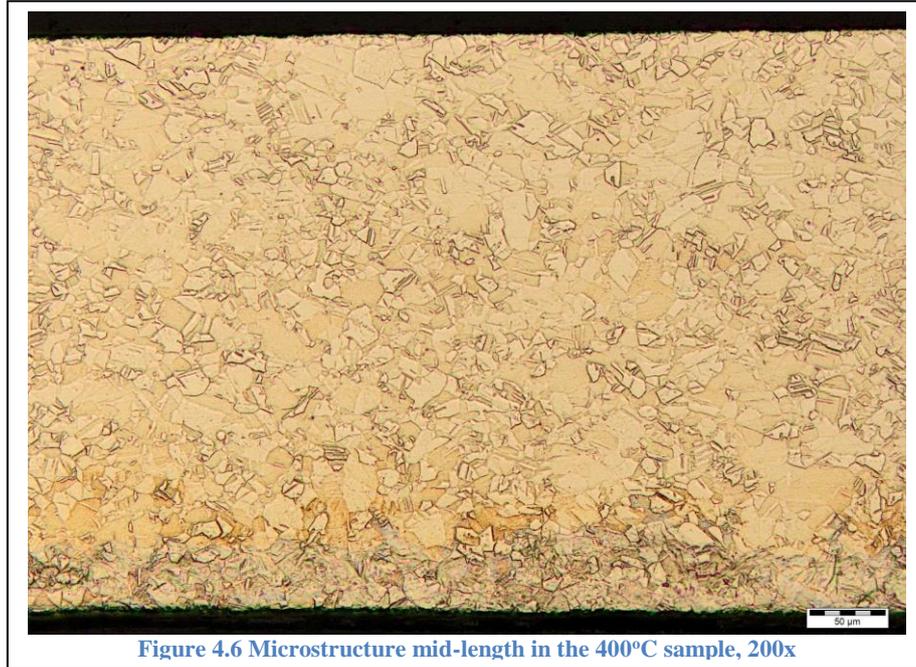
In these samples the microstructure mid-length is shown in figures 4.4 to 4.6. It is evident that the original cold-worked structure has recrystallized and grain growth is occurring as the temperature increases.

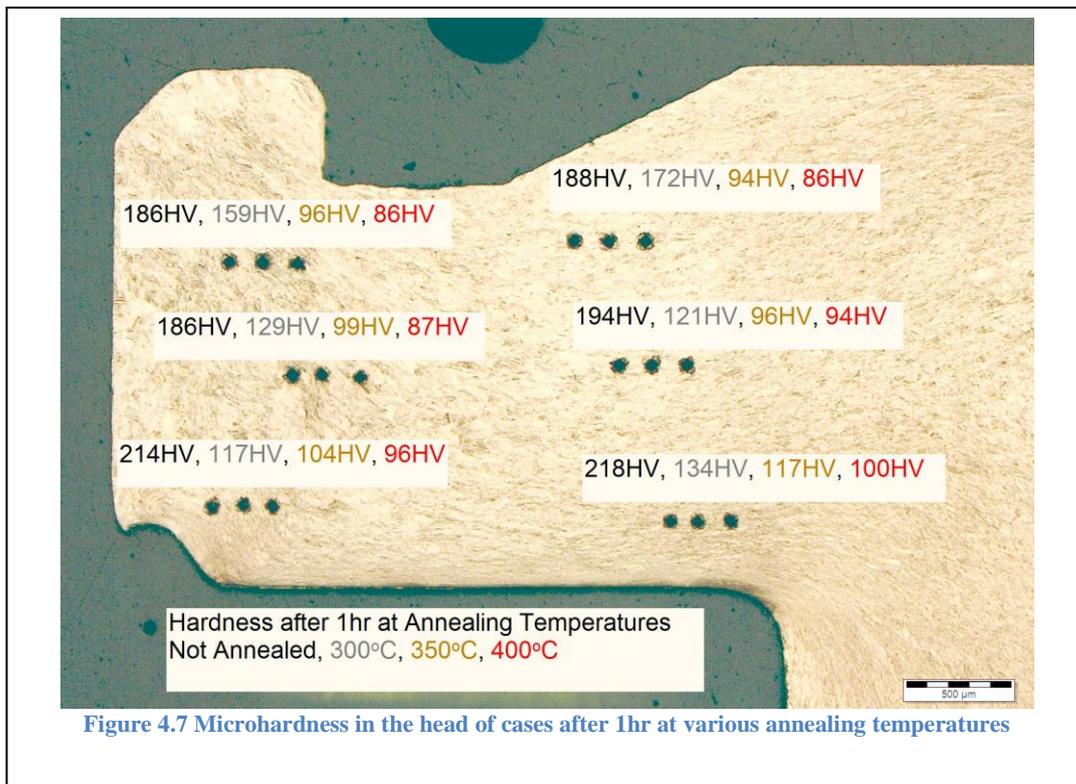
In the head area of the annealed cases we observe some softening as shown in figure 4.7. The cases as supplied have a cold-worked microstructure in the head area which metallurgically means that the brass is strained and full of dislocations – all of which increase the internal energy in the brass in these areas. This means that during the annealing cycles carried out on these cases the cold-worked microstructure will undergo recovery, recrystallisation and grain growth with a reduction in hardness. We must remember that the neck area in these cases already underwent an annealing cycle during manufacture whereas the head area has not been annealed prior to our annealing cycles.

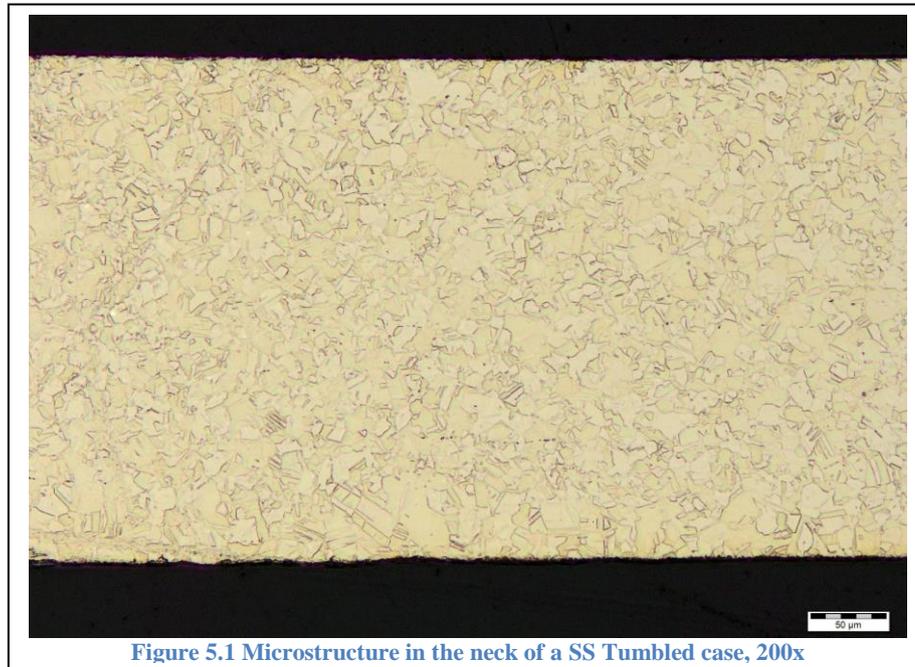
Examination of the cross-section of a case which was tumbled in stainless steel shows no obvious deformation of the microstructure, see figure 5.1. Microhardness testing on the cross-section shows a hardness of 98HV.

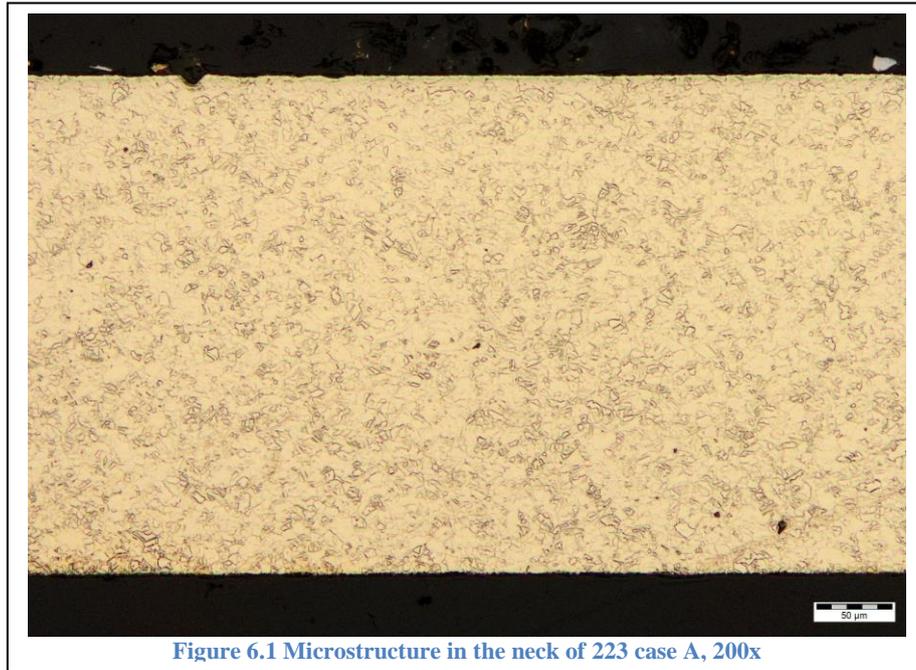
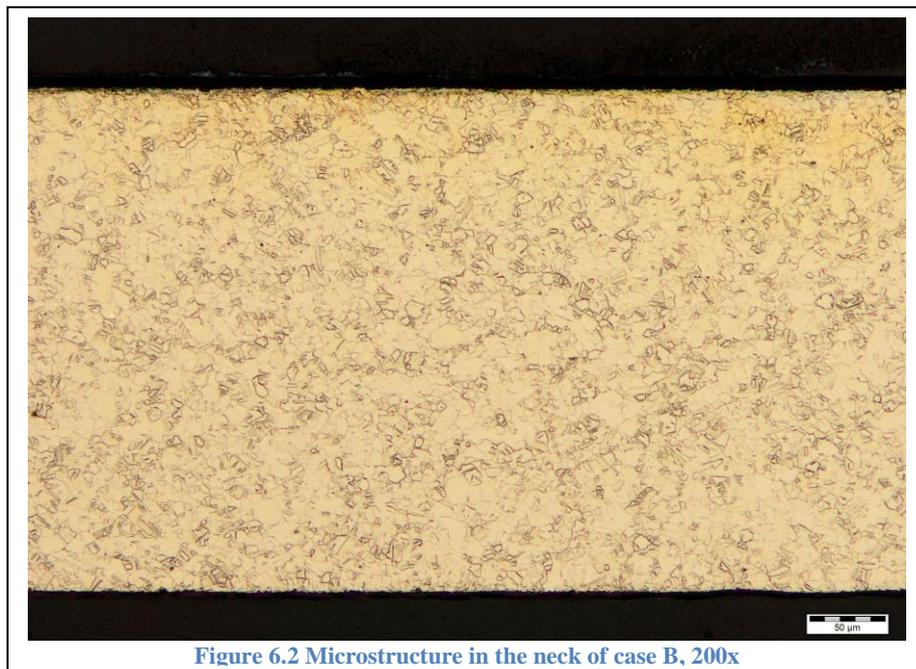
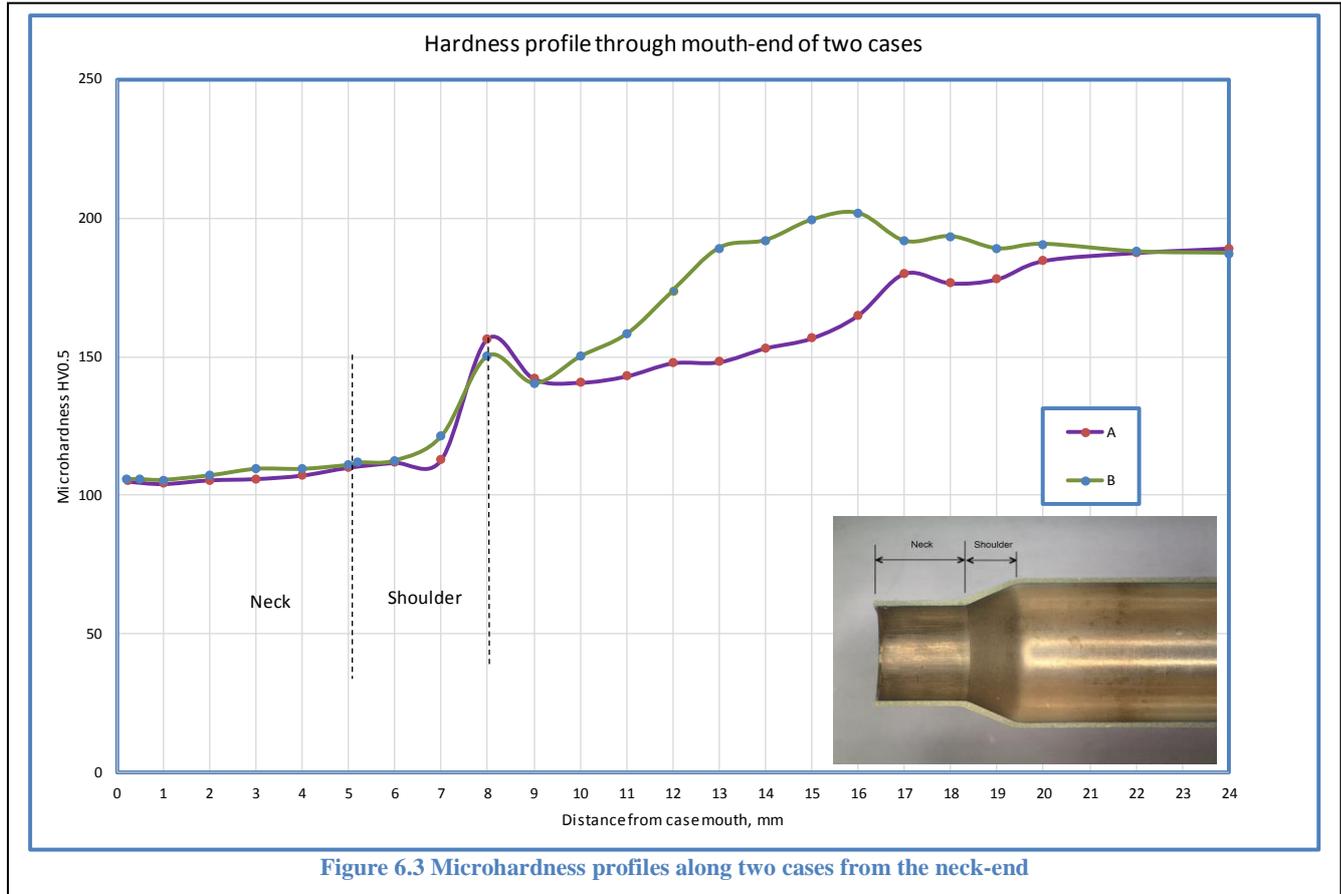
There are no obvious visible differences in the microstructure in the neck area of the A and B cases as shown in figures 6.1 and 6.2. Microhardness in the neck and shoulder regions of these two cases are virtually identical as shown in figure 6.3. Between 9mm and 22mm from the mouth end the A case generally has a lower hardness than the B case, see figure 6.3.

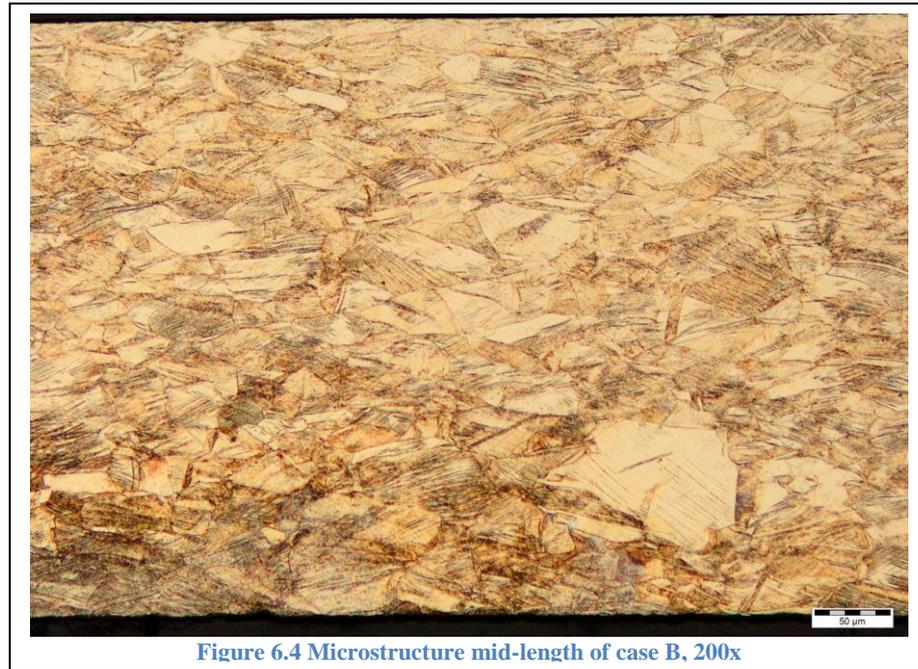
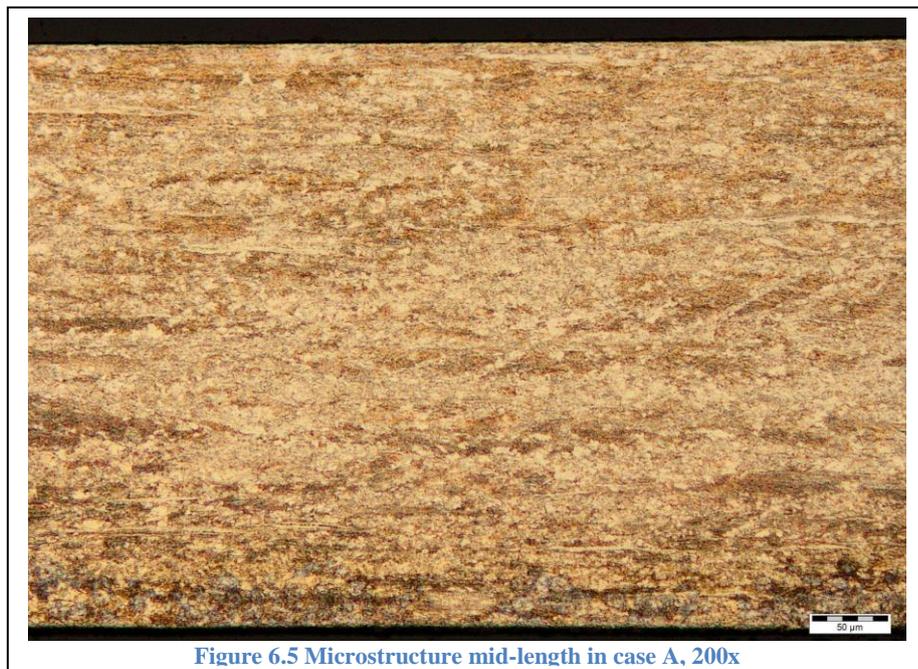
The microstructure mid-length between the A and B cases shows that the brass in B is cold worked whereas A is much finer grained, compare figures 6.4 and 6.5.

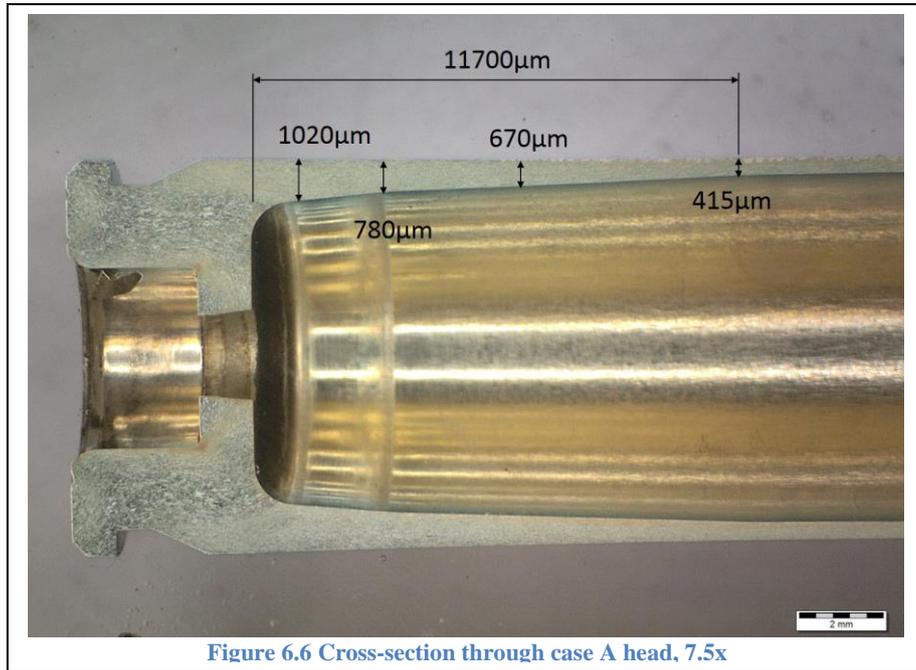
Figure 6.6 Cross-section through case A head, 7.5x

There is a difference in the design of the forming tools as seen in figures 6.6 and 6.7 where the taper from the side-wall to the head is longer in case A producing different wall thickness measurements. Close examination of these two figures also shows how case A has a finer grain structure.

There are some dimensional differences at the case head between the A and B cases as seen above. Measurement of these features was carried out with the aid of the microscope software. Figures 6.8 to 6.11 shows the differences measured.

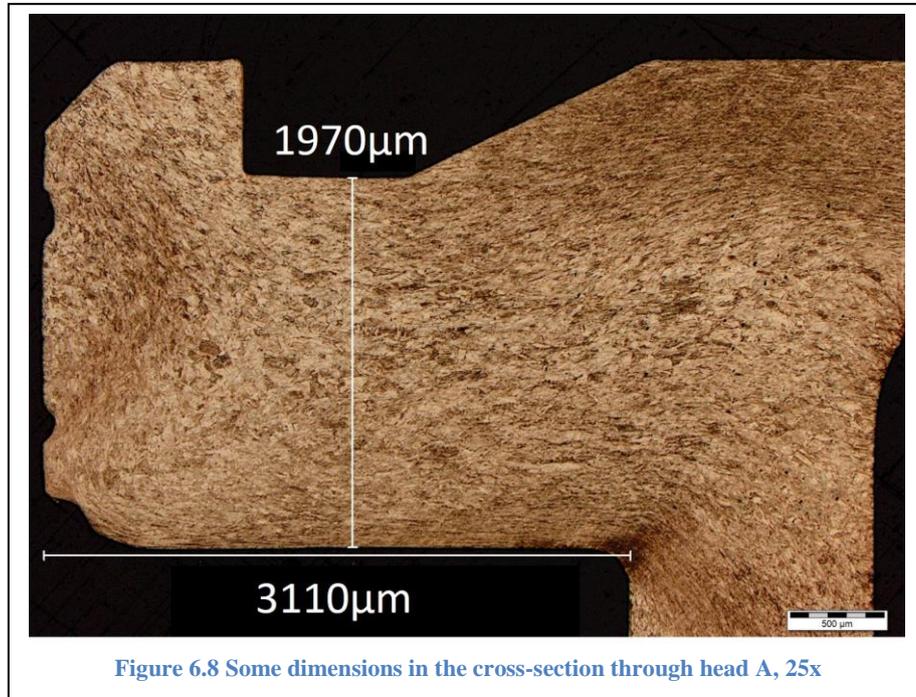
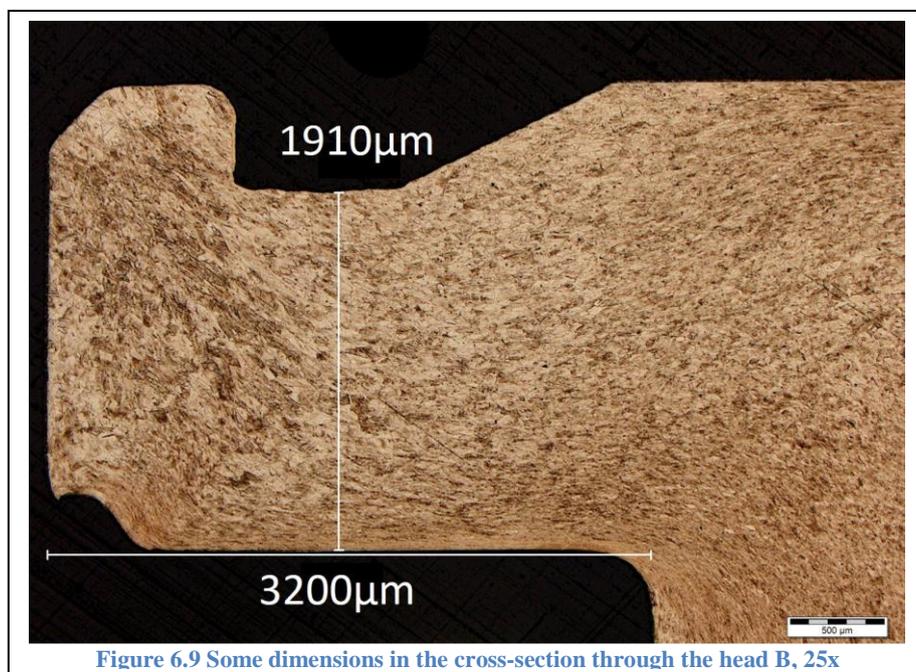
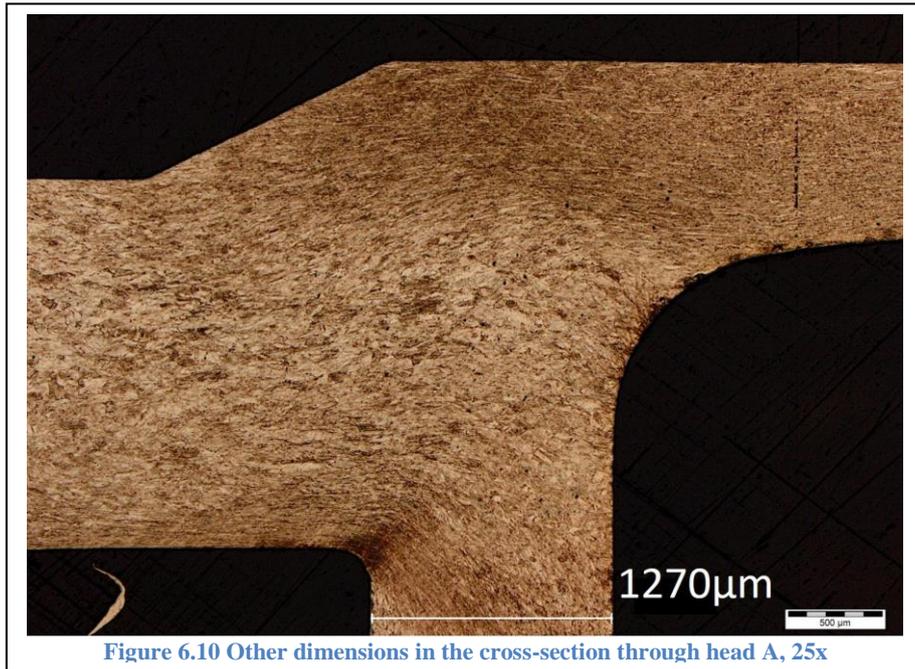
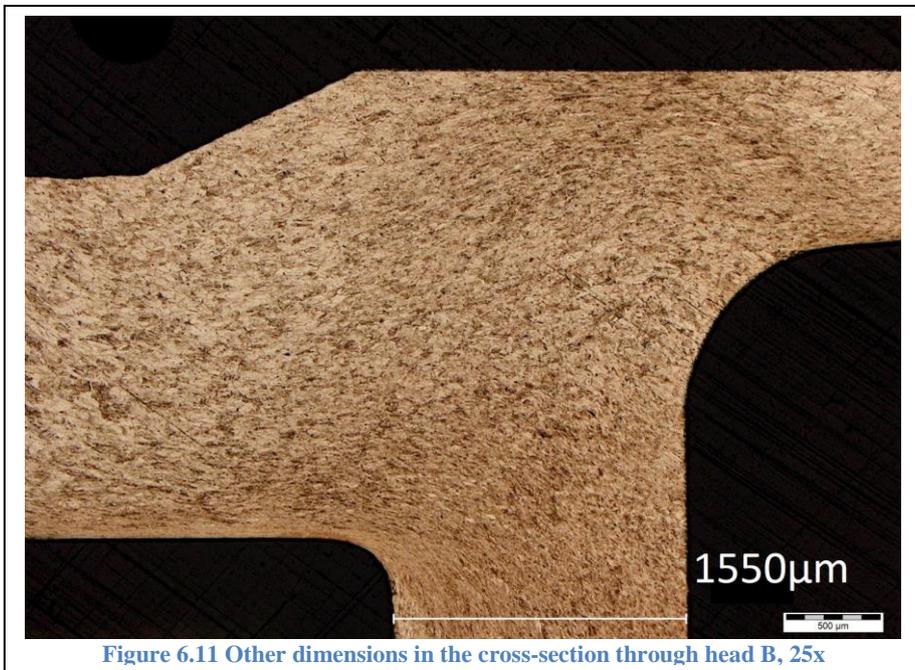
It is evident in figures 6.8 and 6.9 how in the head area of the cases the microstructure varies considerably. Around the tighter corners the grains in the brass are compressed and worked far more than in the middle of the head. Microhardness testing was carried out in six different locations in each head as shown in figures 6.12 and 6.13. In the head of case A the hardness ranges from 183HV to 205HV and in B the head the hardness ranges from 186HV to 218HV. Considering the range in hardness and differences in microstructure observed it is difficult to think of the head as having one specific hardness.

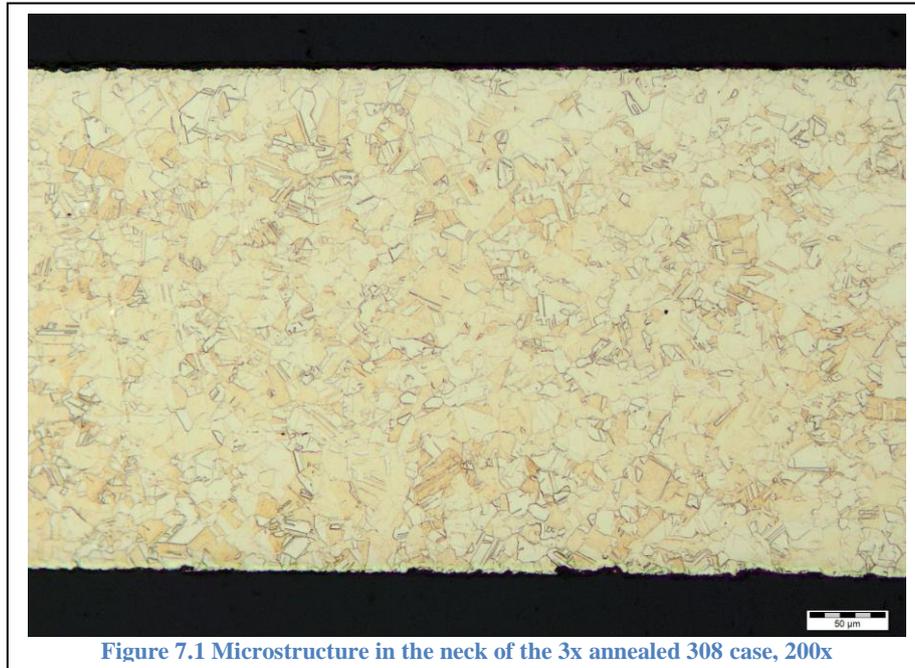
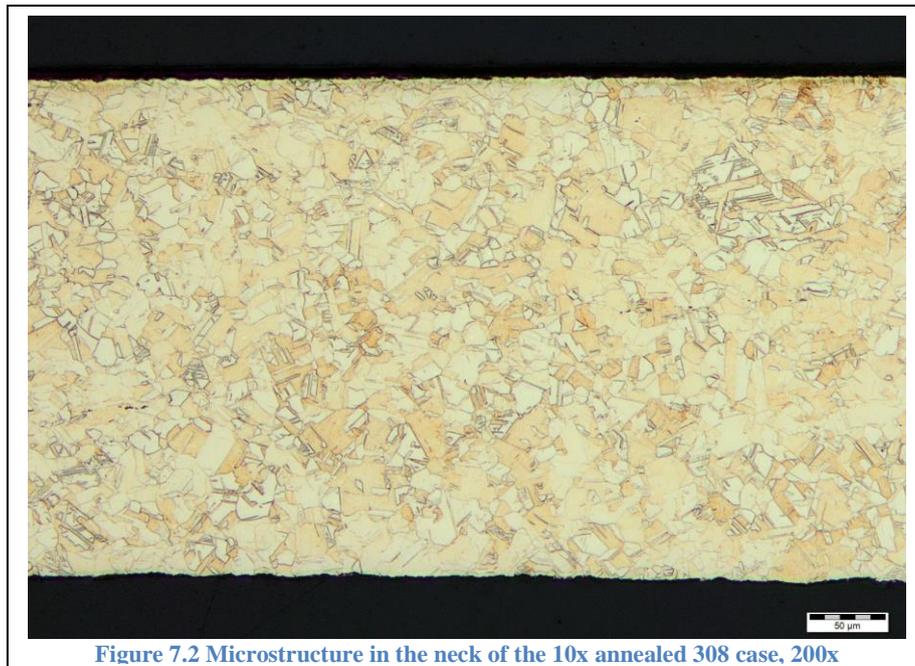
Examination of 308 cases shot and then annealed 3x and 10x respectively shows no difference in microstructure as shown in figures 7.1 and 7.2. Microhardness traversing in the neck area shows a 10HV difference in hardness between the cases as shown in figure 7.3.

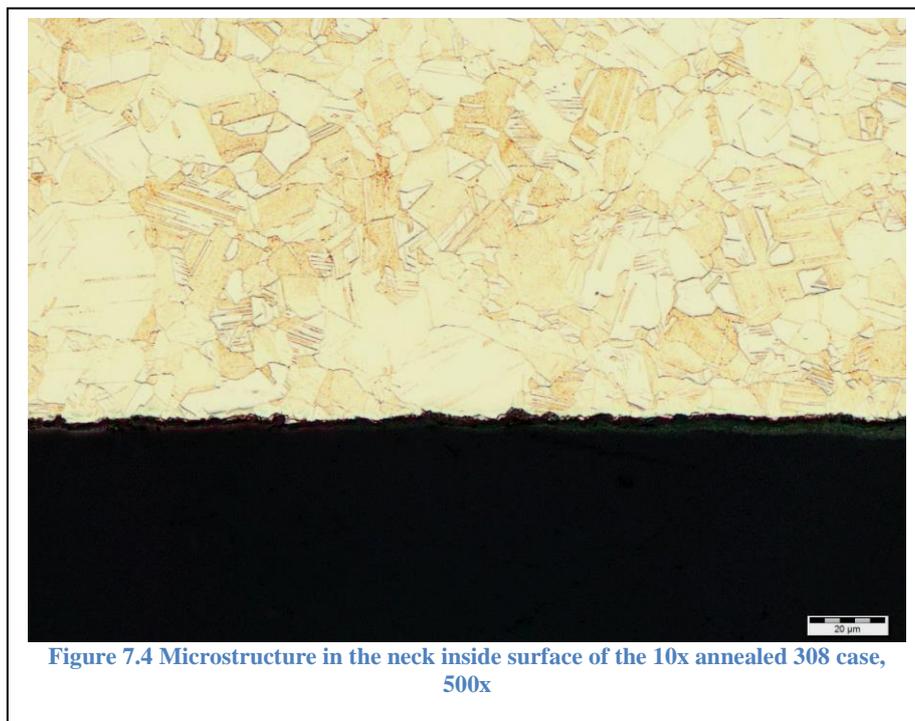
Figure 7.4 Microstructure in the neck inside surface of the 10x annealed 308 case, 500x

At the inside surface in the neck of the case annealed 10x the brass appears in good condition, see figure 7.4.
